# 2022 CITY OF EVANSTON ADA TRANSITION PLAN

City of  
**Evanston**

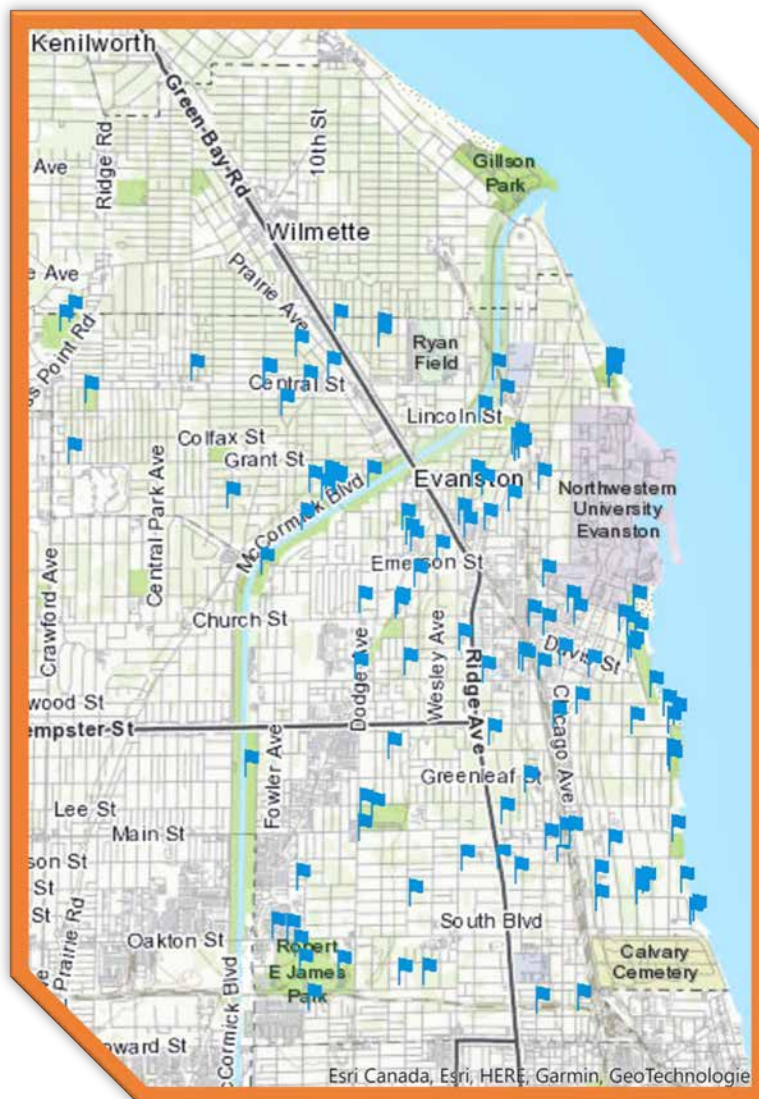
*Map showing locations of parks and facilities inspected*

As part of the Plan, a self-evaluation survey of 119 City-owned parks and facilities was performed over a two-month period from September 2021 through October 2021. The map below indicates the location of all park facilities included in the self-evaluation. A full list of parks and facilities is provided in Appendix 3.

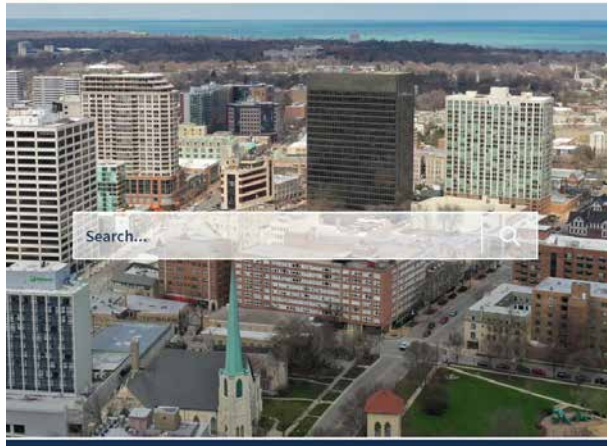
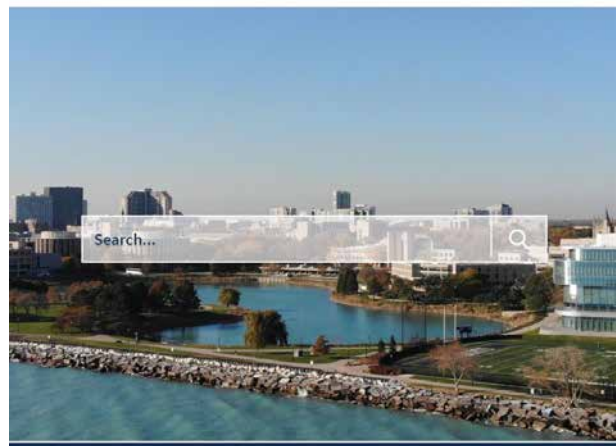
Issue: The homepage carousel has no pause/stop controls. Users cannot interrupt the auto-playing hero image rotator behind the homepage search feature.

| COE-025 | Image rotator lacks user controls | Home | <p>The homepage contains an image rotator that lacks user controls to pause or stop rotation. Keypress event scripting allows users to navigate the images using the arrow keys, but no mechanism exists to stop the image rotator from updating.</p> <p>Alternatively, implement full carousel widget markup and interaction patterns as suggested by the WAI-ARIA Authoring Guidelines.</p> | 2.2.2 Pause, Stop, Hide | A | Medium |

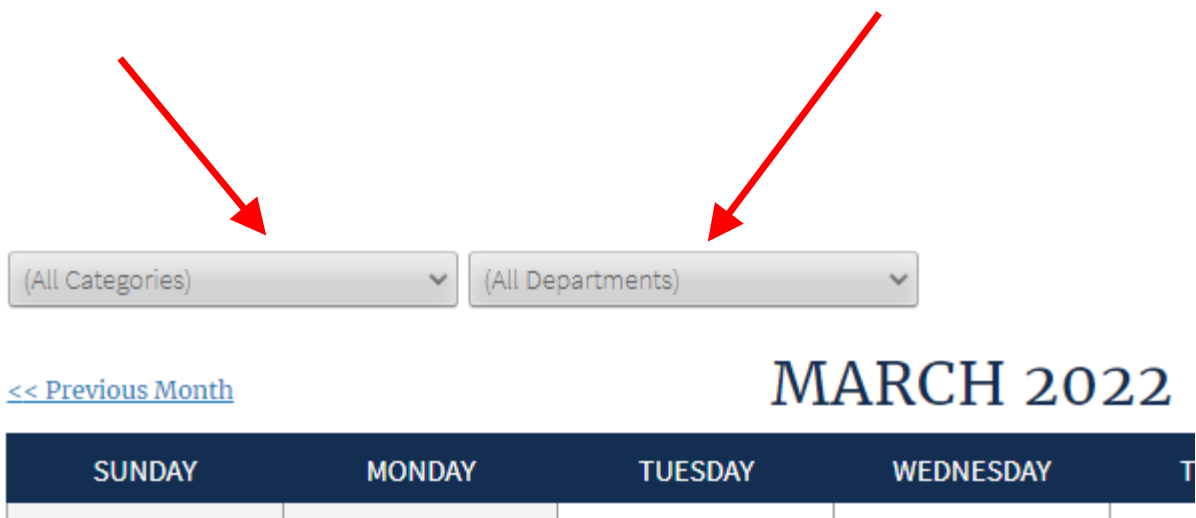
Issue: Calendar filter fields lack accessible label values. All fields require properly associated label values using top-level label attribution.

Issues: Calendar filter fields submit on user selection. User cannot filter the calendar content by multiple dimensions in a single page load.

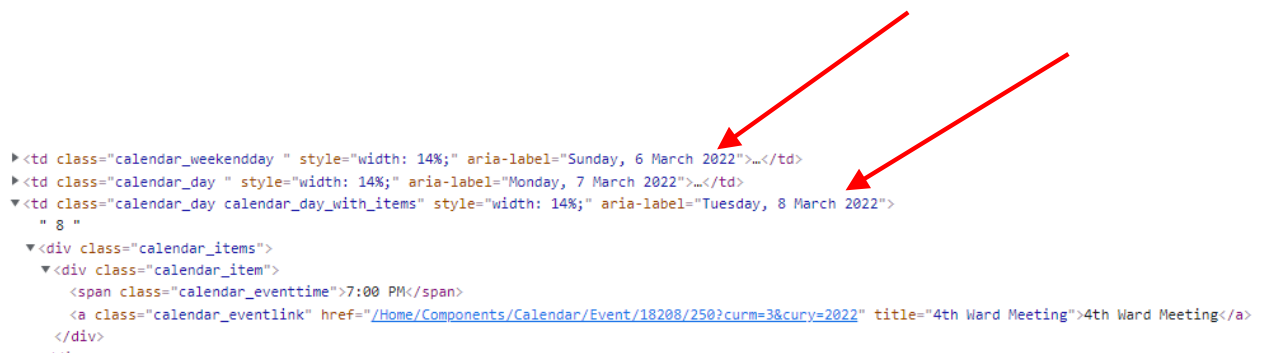
Issues: Calendar table cells employ aria-label values to create a full date value, but the contained text content (beginning with the date number) along with the day of the week table header association creates the same context for users. Most are not exposed to the label value on the table cell in normal table navigation.

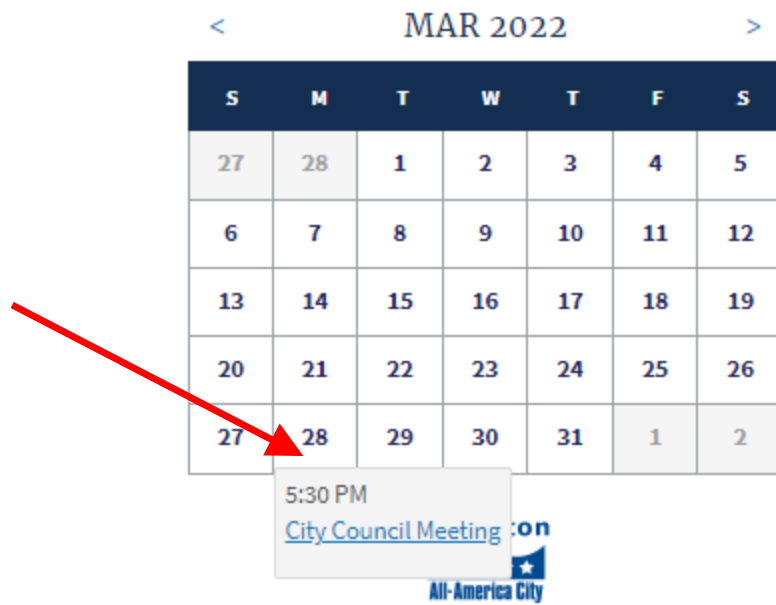
Issues: Small screen version of calendar employs hover-based tooltips to display the event item content. Screen reader and keyboard users cannot activate the tooltip or perceive the collapsed event item content in each date cell.

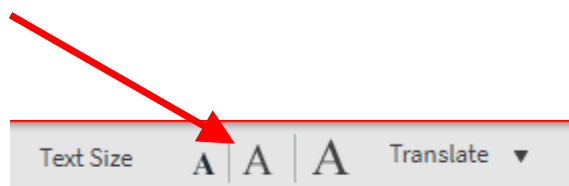
Issues: Font size selector options do not maximize at 200% text zoom. The largest font size increase available via the widget is 168%.

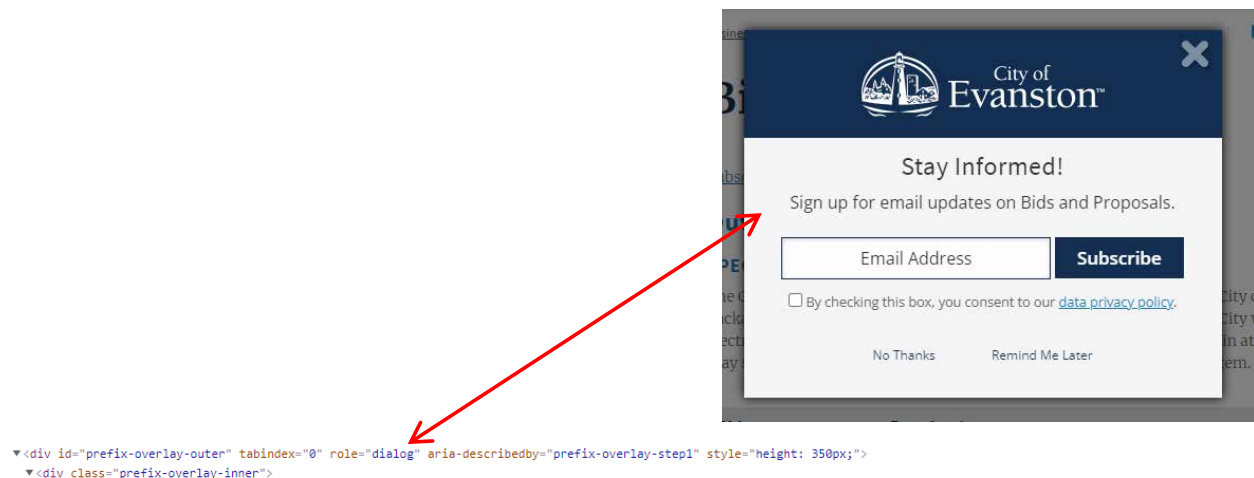
Issues: Modal dialog widgets lack aria-modal attribute values. Some assistive technologies may use this attribute to distinguish non-modal dialog windows that do not display the main content as visibly inert.

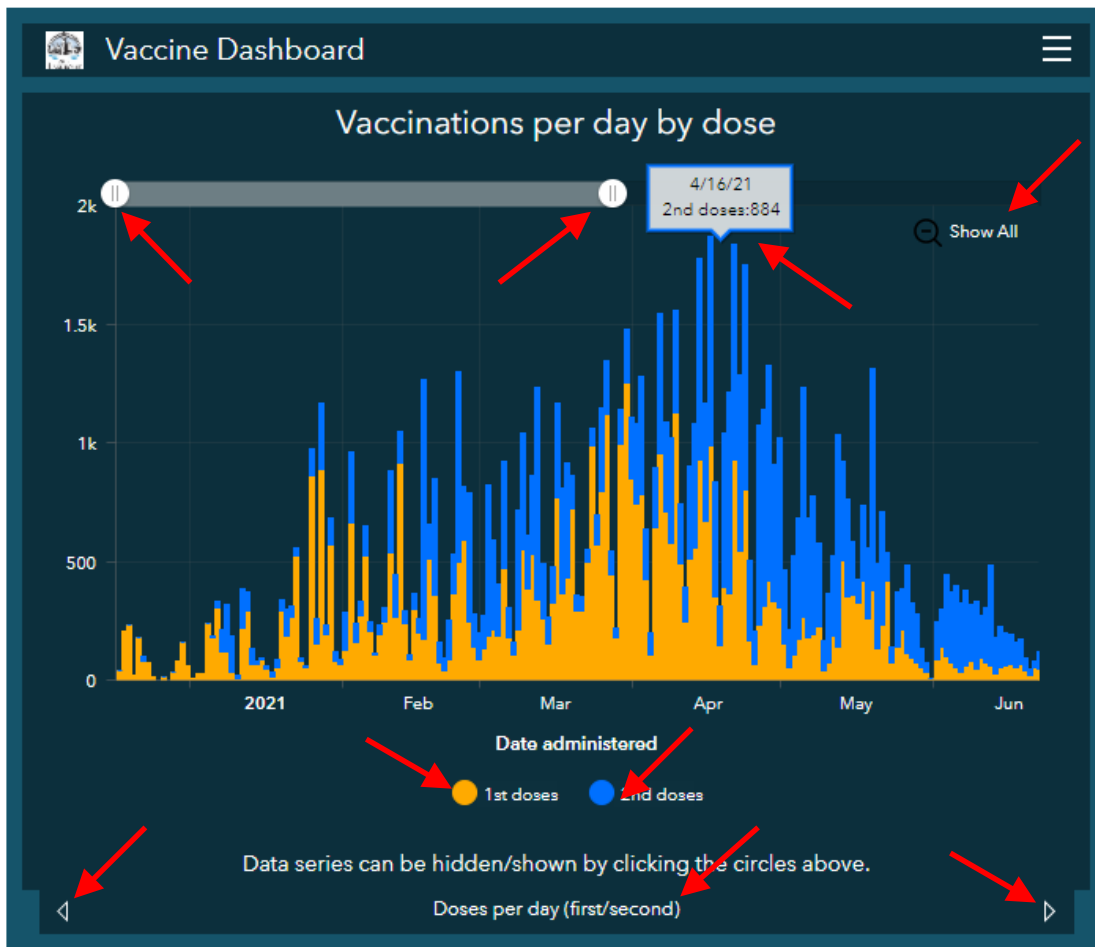
Issues: Some dashboard controls are not keyboard operable. Many of the controls (menu toggle, pager controls, in chart slider controls, hover tooltips, etc.) are composed of `<svg>` child elements that have click event handlers implemented to allow interactivity. Assistive technology users would not be able to fully operate the dashboard content.

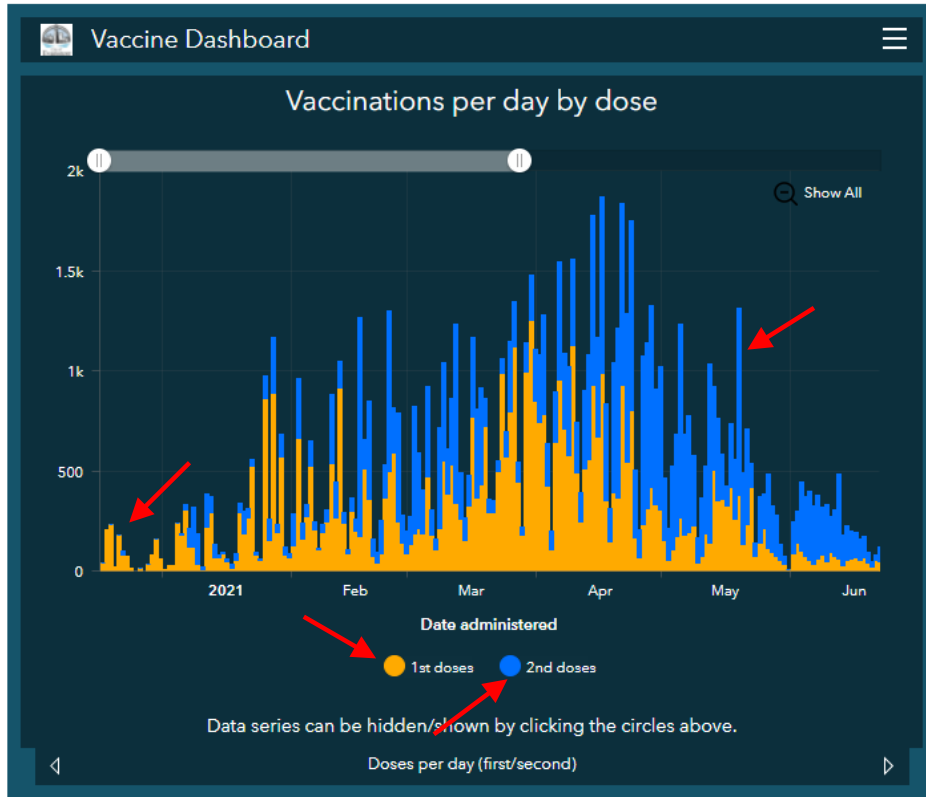
Issues: Data visualizations use color only to identify data categories. Color should not be the sole means of differentiating data categories or identify an interactive element.

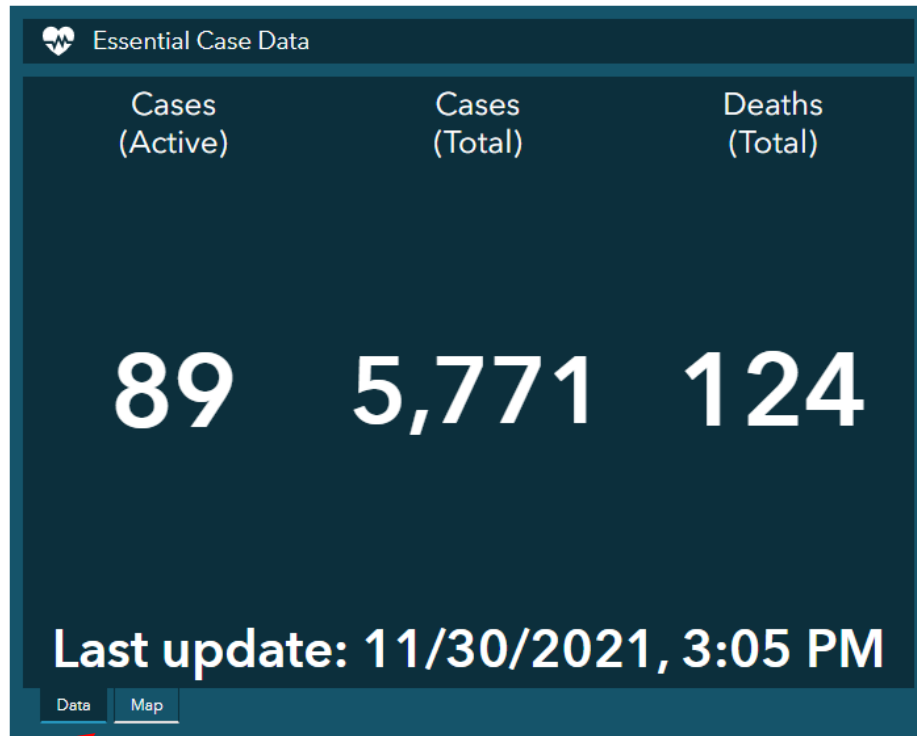
Issues: The visible layout and functionality of the dashboard is a tabs widget, but assistive technology users cannot activate the controls. Users may be unsure how to interact with the widget, the active tab state and the implied layout due to the lack of relationship and state attributes markup.
